# The Big Hole of Starkholmes

John Jones

**Abstract:** A major ground collapse at Starkholmes, near Matlock, was caused by inappropriate site development over old mine workings.

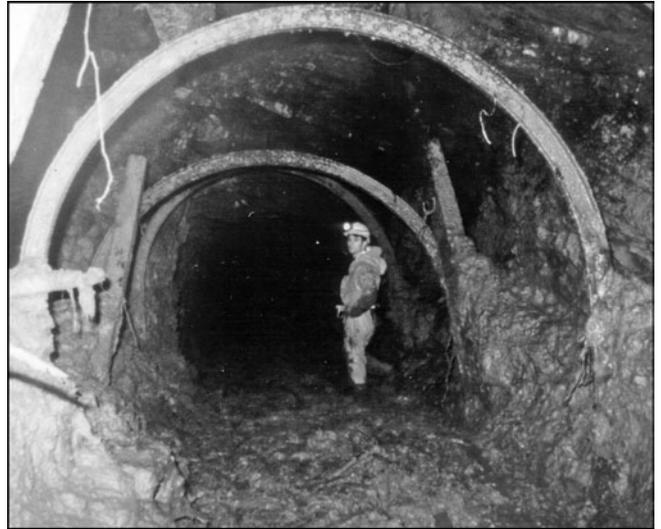
**Figure 2.** The Ribber Mine inclined drift, with steel arch roof supports at critical points (photo: Paul Barsby).

northeastwards towards Ribber for a distance of 275 m. Starting at 149 m OD, this descended on a gradient of 1 in 3.5, to reach a level of 67 m on the vein (Fig. 2). It was then found that the 1.2 m rib of galena intersected by the drilling was only a pillar left by the “old man”. If the borehole had deflected by a fraction of a degree either side, the Ribber Mine would never have been developed. However, the Johannesburg Company carried on working the mine until April 1956, when Derbyshire Stone took over and worked the mine until closure in 1959.

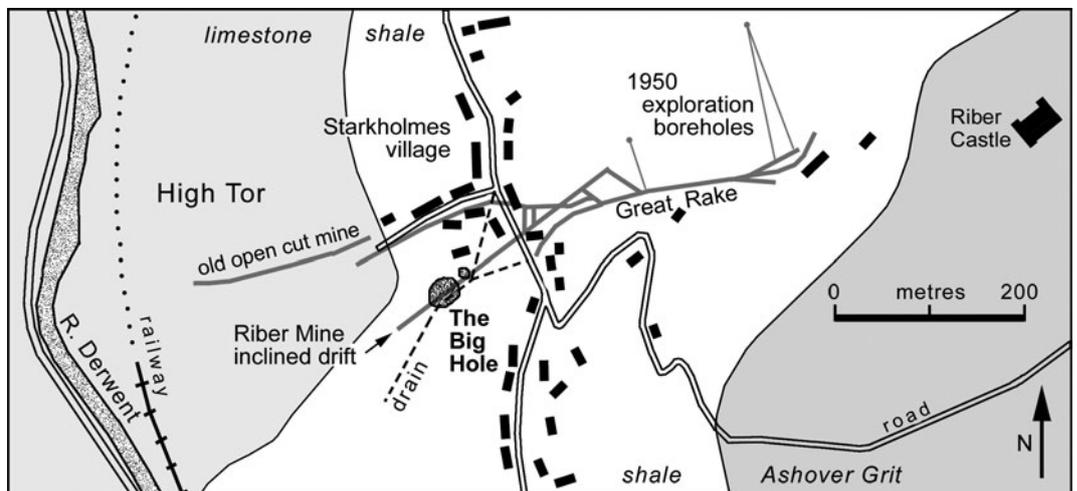
But drilling in the east was more promising, where many veins are associated with the Great Rake along its length. Three inclined boreholes were drilled towards the south to intersect a rake length of 200 m, and all three were successful (Fig. 1). A major vein was encountered, at one place with 1.2 m of galena within a thicker calcite vein. The other two boreholes found sphalerite, also with galena values, and again in a calcite vein 2 m wide. The drilling programme seemed to indicate reserves of 60,000 tonnes of ore with a combined lead and zinc content of 8%, all lying below the level of the Derwent. This more than justified the cost of opening a new mine (Varvill, 1959; Greenough, 1967; Ford, 2002).

**Figure 1.** Main features of the mines and geology around the Big Hole at Starkholmes.

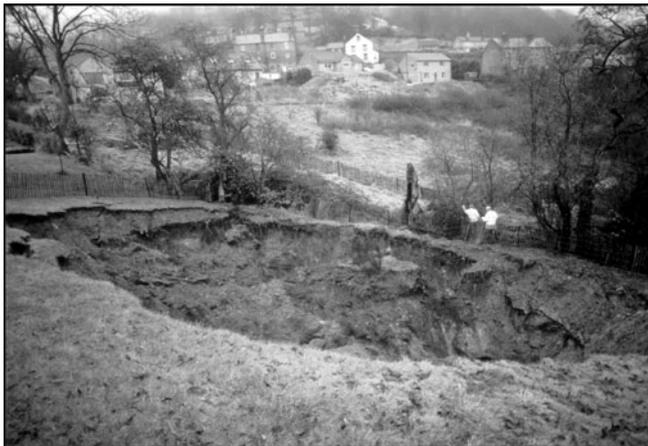
**Figure 3.** *The Big Hole on October 23rd.*

garden. Early in 1989, the new owner dumped quarry waste on to his garden extension, without planning permission and without knowledge of what lay below the ground. Later that year, and having been granted retrospective planning permission, he landscaped the site using 6000 tonnes of landfill. However, he had unknowingly crushed a clay drainpipe that extended beneath his plot, and crossed above the inclined drift. This culvert took stormwater from the road through the village, down towards the River Derwent.

Some three years later, in 1992, it began raining in August, and continued almost unabated through September and into October. During the night of October 16, a hole appeared in the beautifully manicured lawn (Fig. 3). It was not very big, just an inverted conical shape about 10 m in diameter. But the rain kept falling, and by October 23 the new sinkhole had grown to 20 m diameter and 15 m deep. An open hole lay at the bottom, where the roof of the drift had collapsed under the additional load of the landfill when weakened by water from the now-inoperative culvert. The sides of the sinkhole continued to flare out by repeated slumping, as huge volumes of landfill fast

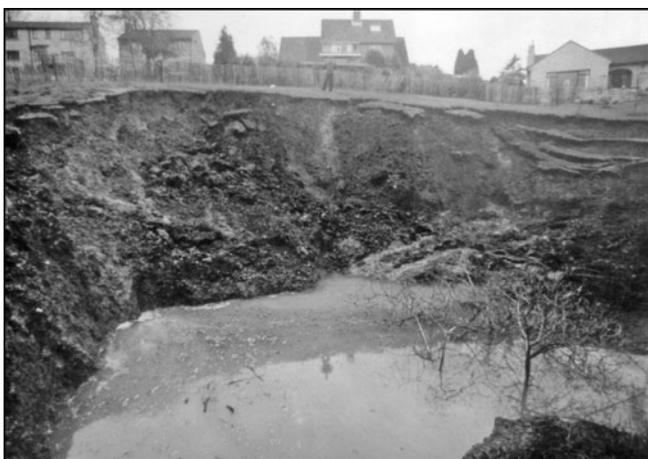
**Figure 4.** *The Big Hole when it had filled with water on November 10th (photo: Paul Barsby).*

disappeared down into the mine. By November 10, the Big Hole had extended to an area 30 m by 20 m, and it was full of water (Fig. 4).

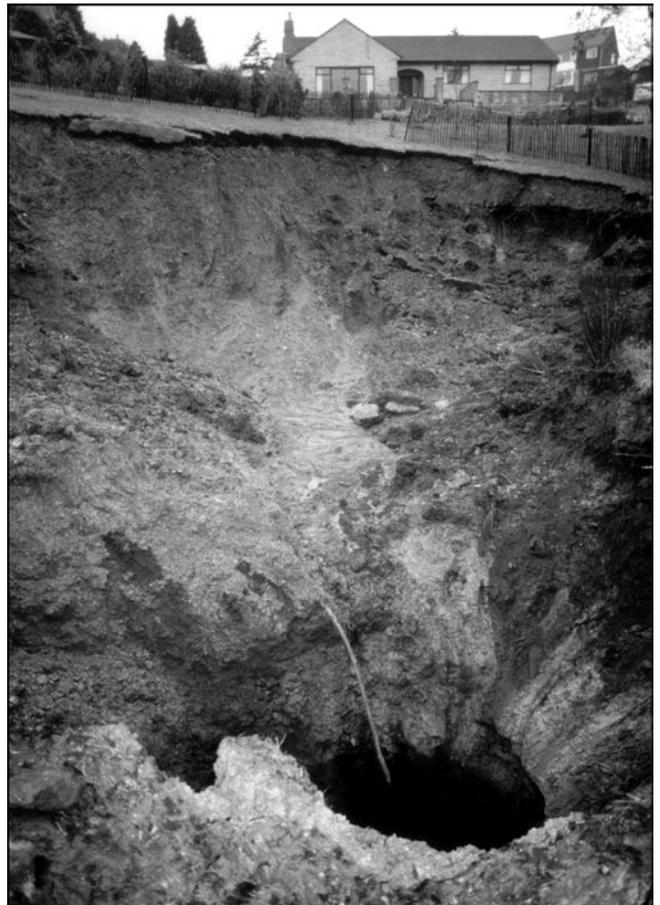
**Figure 5.** *The Big Hole on November 11th, with the broken electric cable visible after the water had drained out.*

During the evening of November 11, the water all disappeared. At the same time, the lights went out in Starkholmes and Matlock Bath. It appears that the water had been held back by a temporary blockage within the inclined drift. When this had failed, the water rushed down in a giant whirlpool. And this had scoured the unstable sides of the sinkhole, with yet more slumping of the newly saturated landfill. The whole process carried away and broke an 11,000 volt electricity cable. However, the water had not travelled far down the incline. It was stopped by another choke, where tonnes of mud and debris were caught within the drift only a short distance down from the open sinkhole, but out of sight.

At 11 o'clock the following morning, a site meeting was called with representatives from Severn Trent Water, East Midlands Electricity, the local council, the county council, Tarmac (who had become the last owners of the mine by their takeover of Derbyshire Stone) and the Wirksworth Mines Research Group. All were gathered round the rim of the Big Hole, staring at the severed 11,000 volt cable that was hanging down its side (Fig. 5). All was peaceful, and it had even stopped raining.

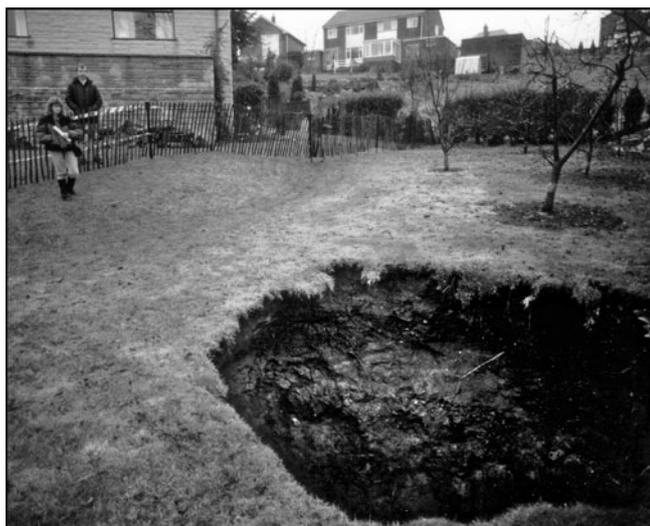
**Figure 6.** The second hole, on the collapsed mine shaft

Suddenly, from behind and in the direction of the house, there was an enormous roar, and a fountain of water, soil and stones erupted 15 m high into the air. Muddy water and debris rained down on to the assembled party, and everyone ran for his life. A second hole had appeared in the sloping lawn. This one was only about 4 m across (Fig. 6), but it was a full 30 m deep. It lay northeast of the Big Hole, and was only a few metres from the landowner's house.

The water in the incline had penetrated and liquefied the mud that had been holding it, so that it could again pour down the inclined drift. This new debris flow of mud and water had then collided with four massive steel ring arches that were lining the drift.

These had been placed by the drift miners where they had intersected a shaft left behind by the earlier lead miners; just a metre in diameter, this shaft had since lain hidden above the ring arches. The same steel arches stopped the progress of the saturated debris flow and water down the drift; but this now had a partial escape route up the old shaft. The pressure of water, air and debris arriving at the blockage in the drift, blew upwards the loose fill within the old shaft.

It then blew out the top of the shaft that had been hidden under the lawn beside the house. What was a metre-square shaft down below expanded to a hole some 4 m across in the lawn. At first this new hole, and the shaft, were full of water, but this soon drained down, as mud, debris and water found their way onwards down the inclined drift.

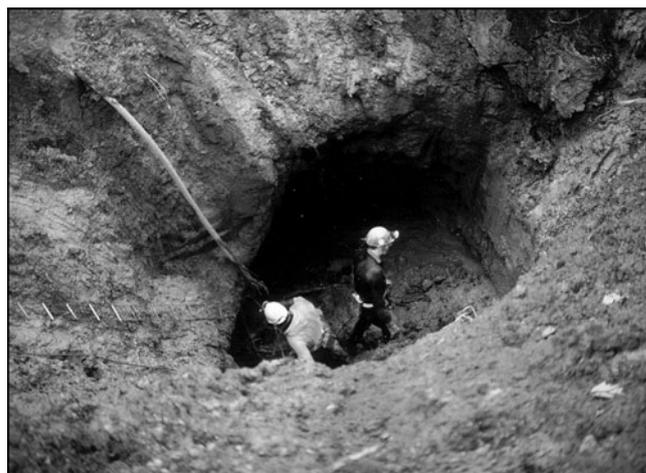
**Figure 8.** Setting off down the drift, from the foot of the Big Hole, to find the cause of the second ground collapse.

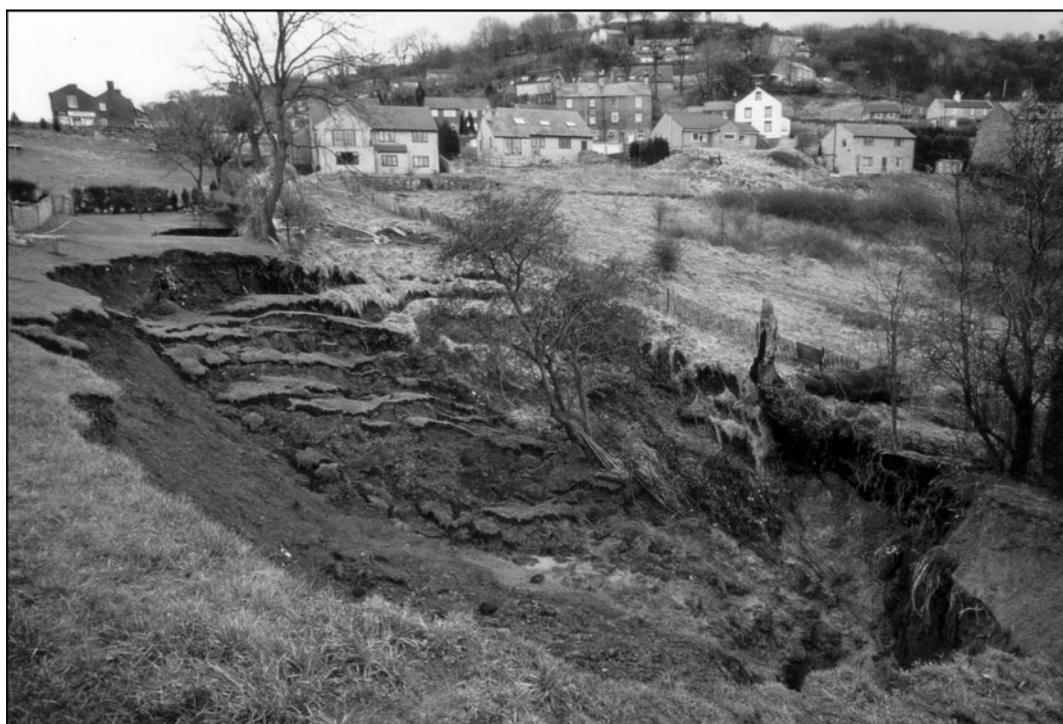
**Figure 7.** Multiple land slips progressively enlarge the Big Hole, until its rim approaches the driveway off to the left; the second collapsed hole is visible beyond the main hole and beside the large tree.

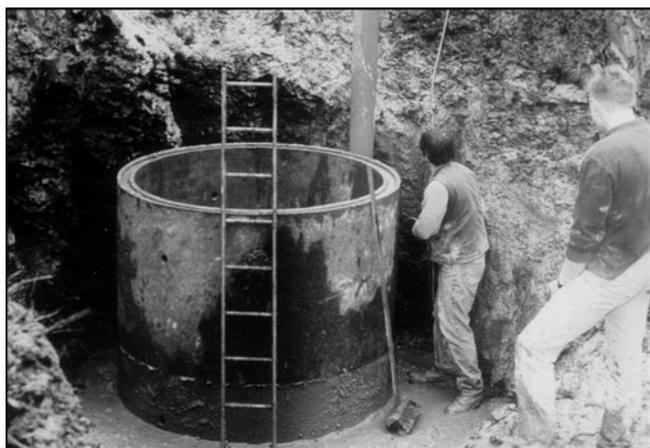
**Figure 9.** The first stage of the new shaft on top of the new access chamber into the drift (photo: Paul Barsby).

So work began on January 15, 1993, to build a concrete access chamber that enclosed the collapsed section of drift. This used 46 cubic metres of concrete, and was topped by an access shaft built upwards with concrete rings (Fig. 9). The shaft reached 12 m high as it was enclosed within the estimated 250 cubic metres of earth poured in to completely fill the crater. The project was completed on February 26 (Fig. 11), when the new access shaft was topped off with a steel lid. The second, smaller, sinkhole and its old mine shaft had also been backfilled.

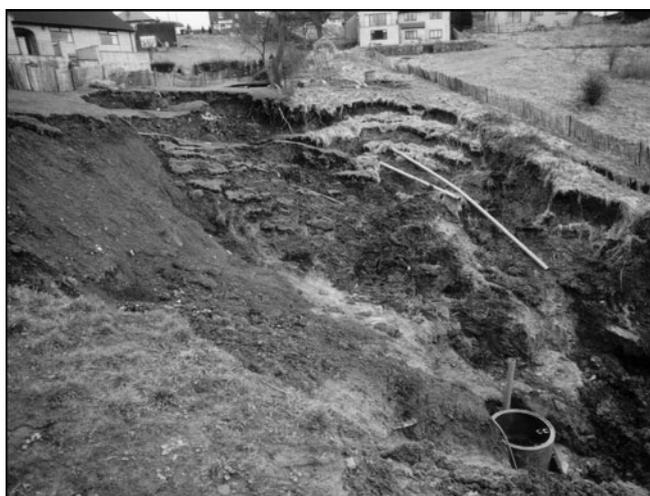
**Figure 10.** Beginnings of the new shaft and the new drains within the Big Hole before backfilling (photo: Paul Barsby).

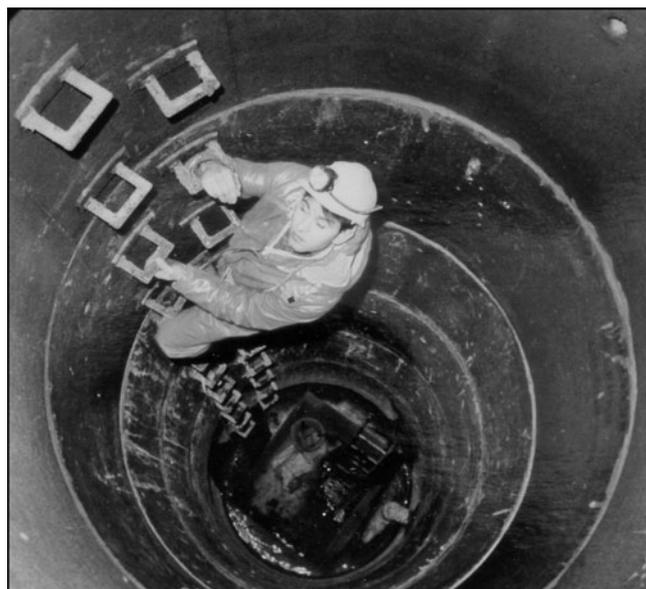
**Figure 11.** Climbing the new shaft (photo: Paul Barsby).
